MEMORANDUM

RE: Shared Use Path Trestle Bridge Crossing the
Zumbro River – Repair or Replacement Options
Zumbrota, Minnesota

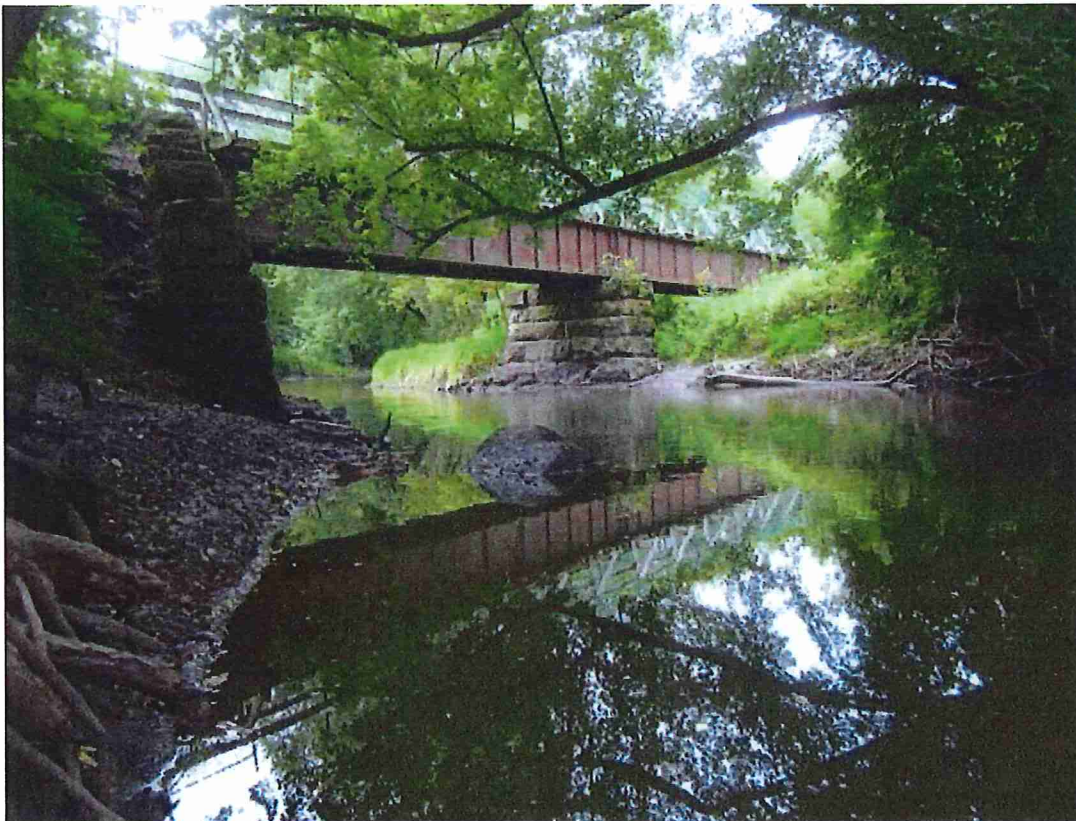
Existing Steel Plate Girder Spans (Looking NW)

The steel plate girders are in overall fair condition for their age. The original paint coating of the structure is mostly gone, but the bulk of the rust on the girders appeared to be only surface rust. The steel cross frames and bracing are in poor condition in places with significant section loss and will need repairs as part of a rehabilitation project. The top flange plates of the girders had some section loss in several places as well.

- **Steel Plate Girders:** Overall the steel girders are in good enough condition that they could be reused. The lateral bracing angles and gusset plates in several places were corroded to the point that repairs are required. The top flange plates appeared to have section loss from corrosion as well due to the timbers trapping moisture. However, despite the corrosion, the capacity of the girders is likely sufficient for the loading required for a shared use path. The shared use path loads are only a small fraction of the original loads from rail traffic that the bridge was intended to carry.

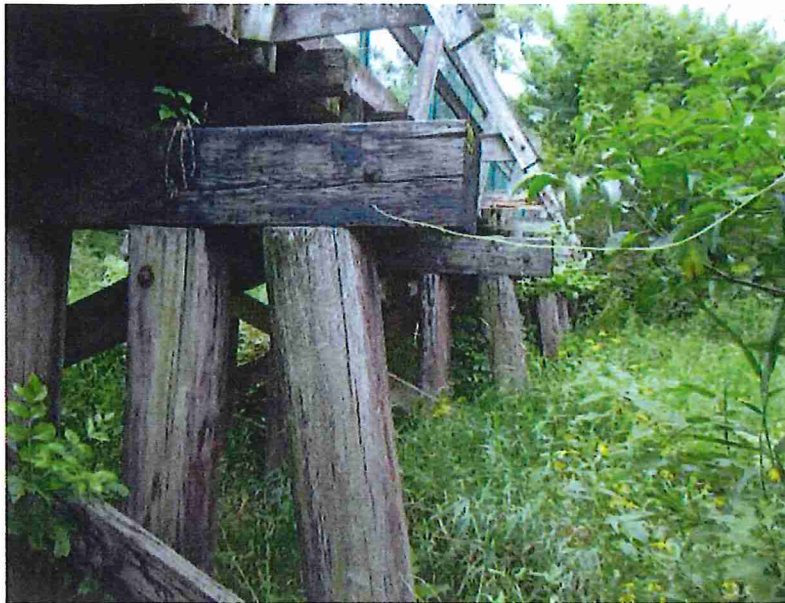
Existing Timber Beam Spans (Looking NW)

The timber beams were visually inspected and sounded in several places with a hammer. Overall they appeared sound and in good condition. One soft/rotten area was noted on an east beam at pier 7 (pier 1 was assumed to be the north most pier).

- **Timber beams:** The beams appeared to be sound and could be reused. Similar to the plate girders the timber beams are substantially oversized for the required loads from a shared use trail, thus a limited amount of deterioration would not pose a problem. It was assumed in the cost estimates that the beams would be removed and reset. This may be required to repair the timber piers, adjust the timber beam heights to accommodate trail elevations, or possibly replace some beams if the deterioration warrants it.

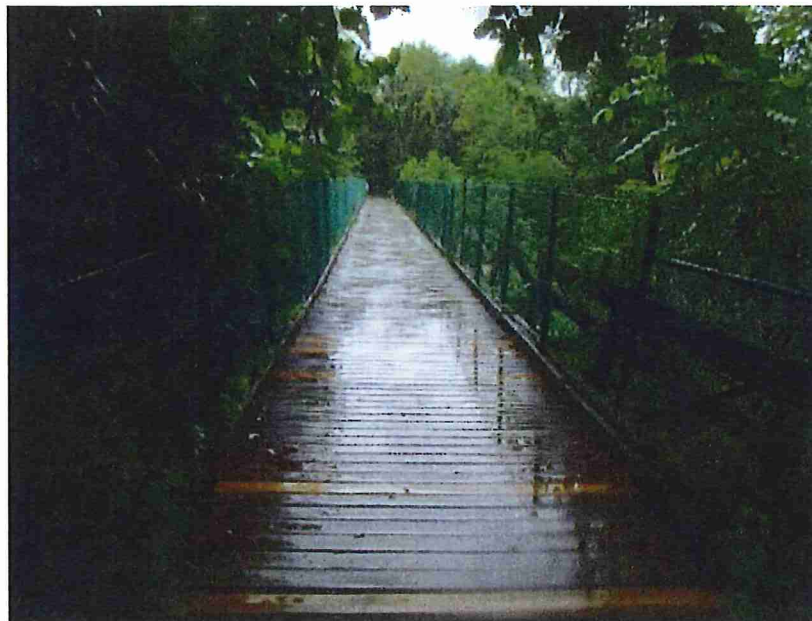
Existing Timber Deck (looking South)

A substantial number of timber 8x8 ties have been replaced recently, along with some deteriorated deck boards. Some original ties that were not replaced are deteriorated/rotten in places. The wooden hand rail had many missing boards. A chain link fence was installed inside of it. The deck and handrail are reaching the end of their service life with many elements in poor condition, and it was assumed that both would be replaced as part of a bridge improvement project.
